TripleA-reno: Demonstration of Combined Labelling Scheme

Introduction: Demonstration buildings

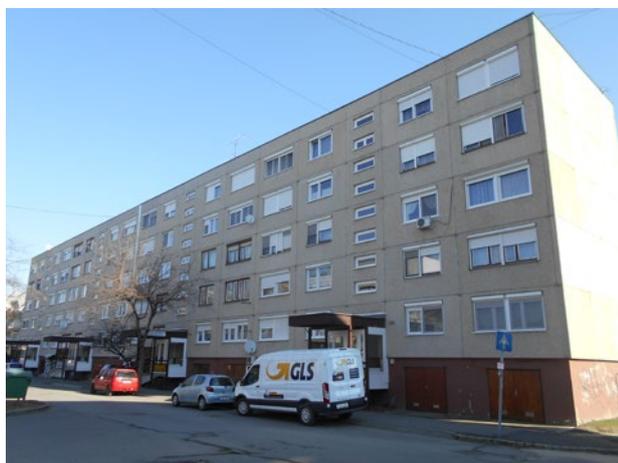
The Hungarian demo building is located in Szigetszentmiklos, 30 km from Budapest. The building was built in 1982 with prefabricated concrete panel construction technology. The building has a total of 60 apartments and the walls and roof have poor thermal characteristics. Most of the windows were replaced with new PVC framed windows. The building is connected to the district heating system, which provides thermal energy for heating and domestic hot water purposes. Within the building there is a 1-pipe heating system, the heating appliances are radiators equipped with a manual valve.

Figure 1. The TripleA-reno Demonstration Building in Szigetszentmiklos, Hungary. A block of 60 apartments which was built in 1982.

Based on the combined labelling, thermal insulation of the walls and roof is recommended, which results in less use of heating and improves the IEQ (operative temperature: indicators 3.1 and 3.2). Installing thermostatic valves on the radiators is recommended, ensuring room control of the heating system, reducing heating energy use, and improving thermal comfort (no more overheating) and well-being (automatic operation). Installing a thermal solar collector system for the whole building is suggested, which reduces the energy use of domestic hot water production and increases renewable energy ratio. There is natural ventilation in the building; therefore, when the outdoor PM is high (during traffic hours or when there is heating of solid fuel in the area), the windows should remain closed if possible.

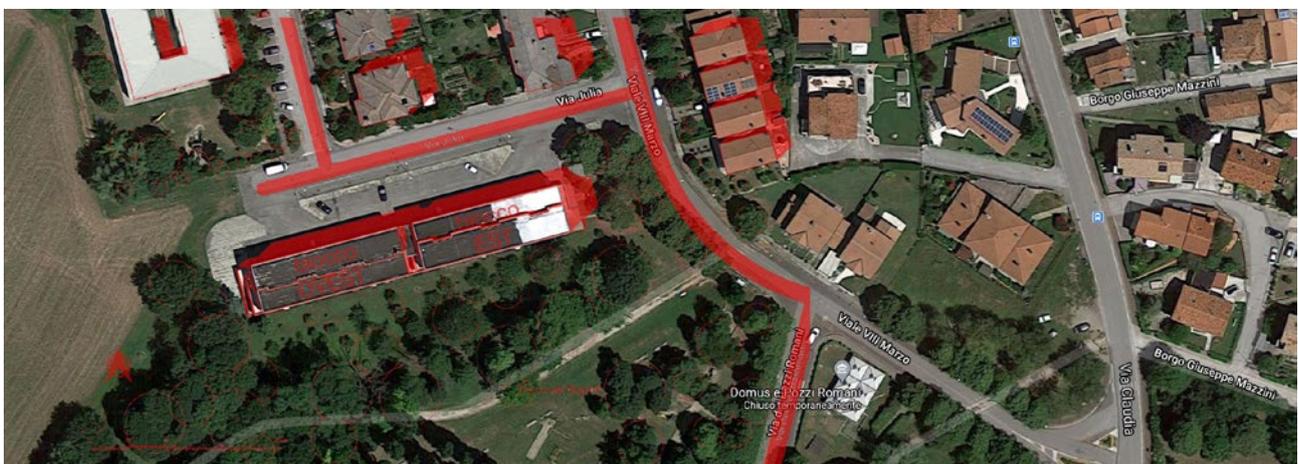
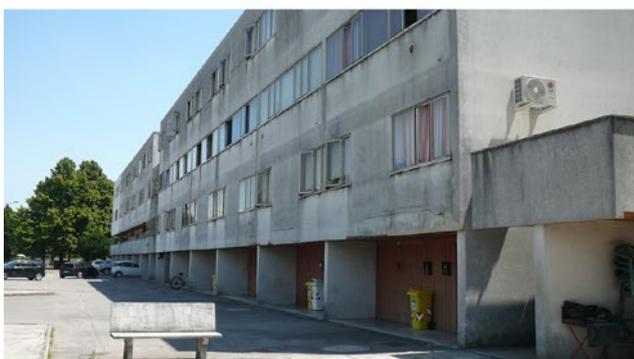
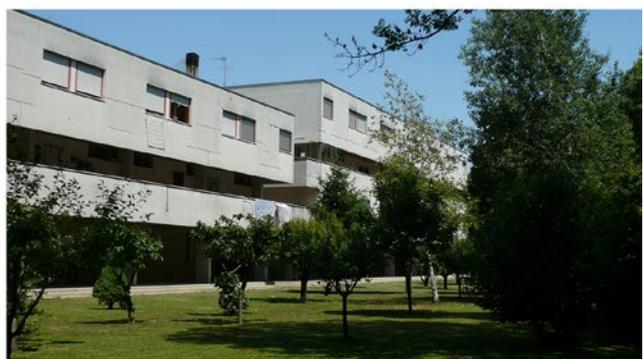
The Italian demo building is located in Concordia Sagittaria, which is 60 km from Venezia. The building was built between 1977 and 1978, is owned by ATER Venezia and hosts 21 apartments on four floors above ground. The external walls are made of a double layer of hollow bricks with thin thermal insulation. The heating system and the domestic hot water production are centralised: there is an oil-fired heating boiler, which provides thermal energy for heating and domestic hot water. The apartments have low performing window glasses and frames, and there is neither room thermostat, nor thermostatic radiator valves to control the indoor temperature.

Figure 2. The TripleA-reno Demonstration Building in Concordia Sagittaria, Italy. 21 apartments built between 1977–78.

The tender of the energy renovation project for the Concordia building is in progress; the design specifications are in line with the combined labelling assessment recommendations for improved energy performance and comfort indicators. The renovation includes the thermal insulation of the walls and roof. All windows and doors will be replaced with thermal break frames and low emission glasses. The oil boiler will be replaced by a condensing gas boiler, improving the energy efficiency. The energy production will be supplemented by installing a photovoltaic system on the roof with 10 kW peak power. Thermostatic valves will be installed in the apartments in combination with the implementation of independent energy consumption accounting.

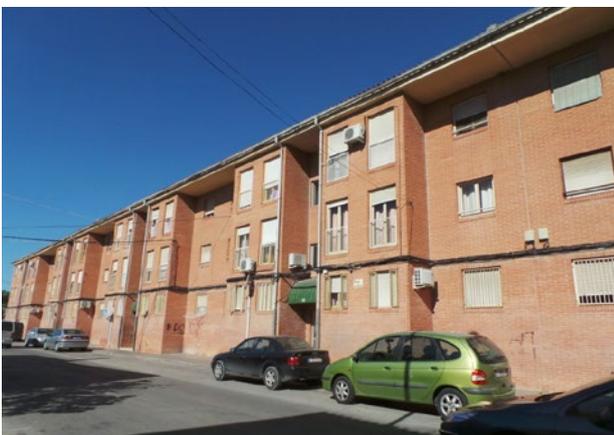
The Spanish demo case is located in Almoradí, a medium-sized town close to the Alicante Mediterranean shore (Costa Blanca). The demo case involves five multifamily buildings built in 1982, and is owned by the Regional Social Housing Company EVHA. The walls have poor energy performance. The apartments were initially constructed with wooden framed windows with single glass. There is electric heating in the rooms and air conditioning unit for heating and cooling in the living rooms. The lack of maintenance and few economic resources of the inhabitants have resulted in a degraded building complex, with an unattractive and outdated image.

Figure 3. TripleA-reno Demonstration Building in Almoradí, Spain. Five multifamily buildings built in 1982.

Thermal insulation of the walls and replacing the windows is recommended, which results in less cooling (and heating) energy use and will improve IEQ (Indicator 3.1 and 3.2, operative temperature). Sealing shutter boxes and perimeter of the windows will improve air-tightness. It is recommended that the home user have information on the indoor/outdoor conditions to make sound decisions regarding the on/off of their air conditioning equipment or open/close windows. Installing a thermal solar collector system for the whole building is suggested, which reduces the energy use of domestic hot water production and increases renewable energy ratio.
